Appendix B

Photos

Part I – Truss Spans

Part II – Kittery Approach Spans

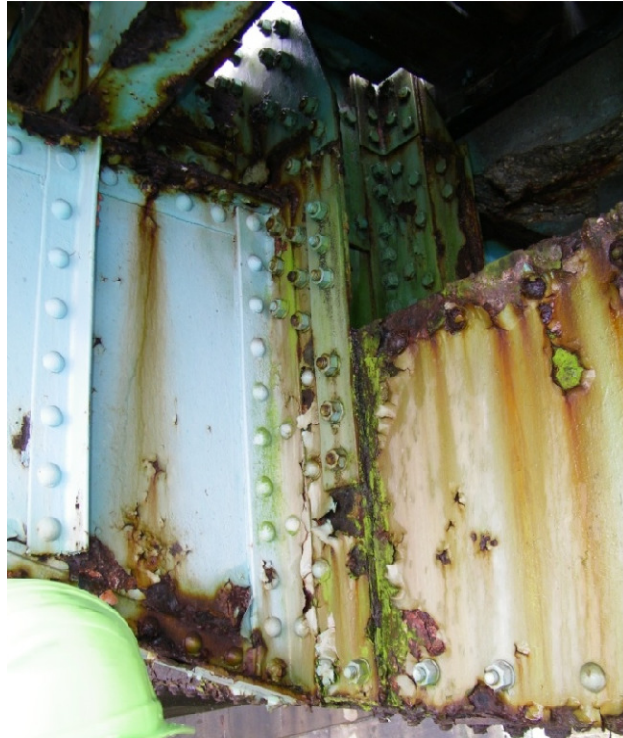
Photo 1.37: Bolted repairs on Span 1 Gusset Plate L1E. Chord web corroded at gusset plate interface.

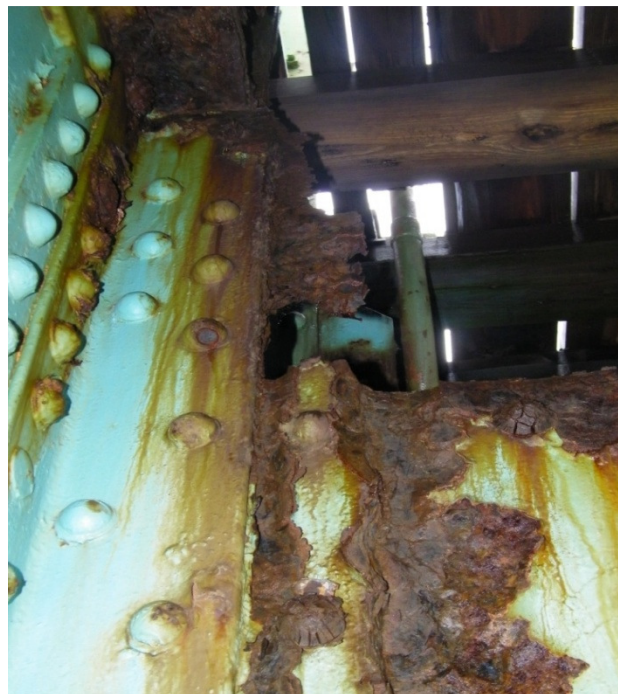
Photo 1.38: Span 3, East Truss Gusset Plate L9, interior side plate. Severe corrosion with 100% section loss in portion of plate.

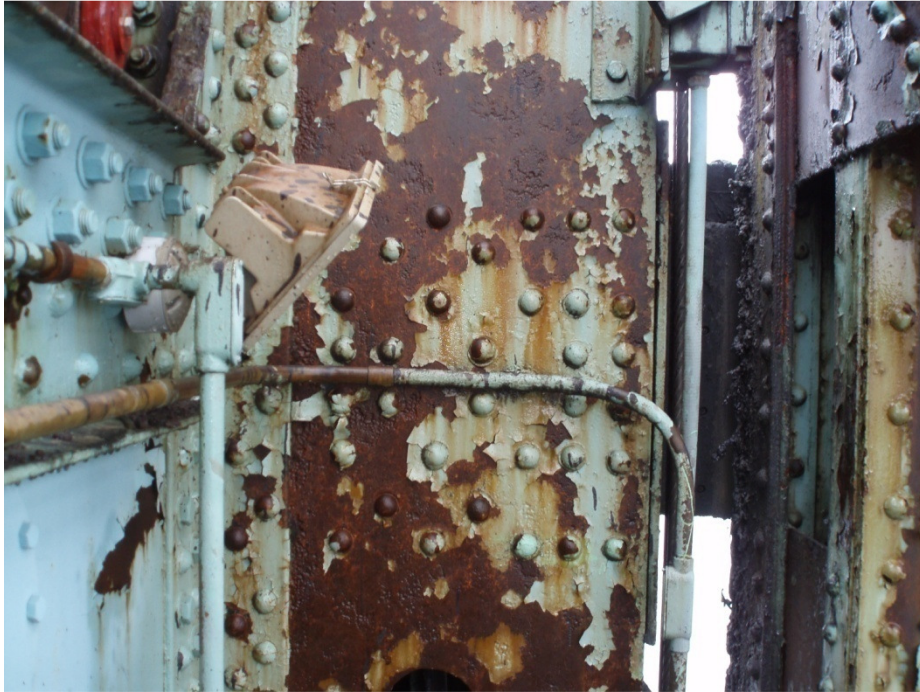
Photo 1.39: Span 2, West Truss Gusset Plate L10. Pitting up to 1/8" deep.

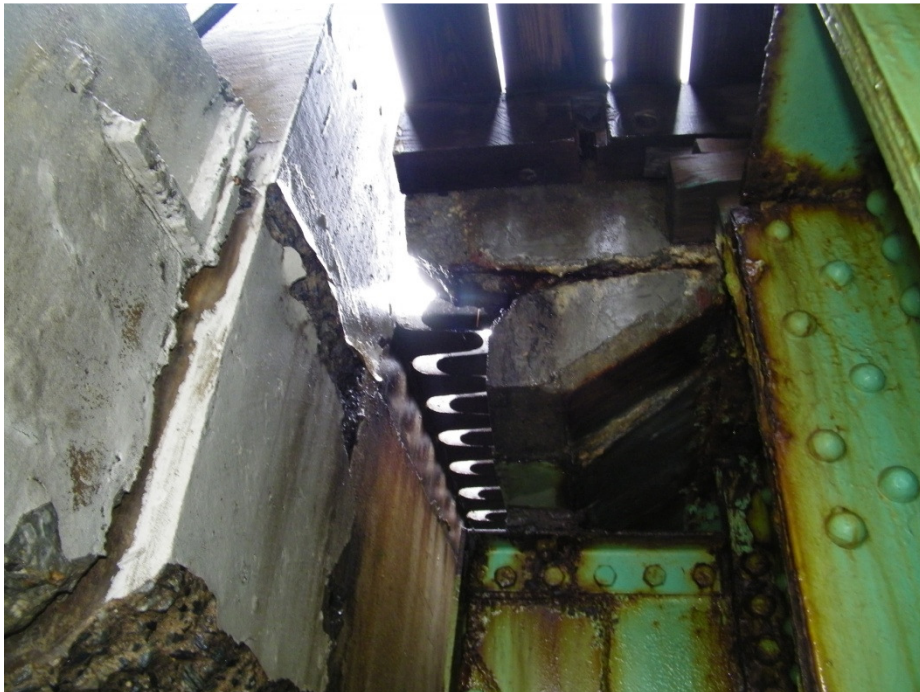
Photo 1.40: Span 1, South Expansion Joint. Deck cracked at expansion joint. Rebar is exposed.

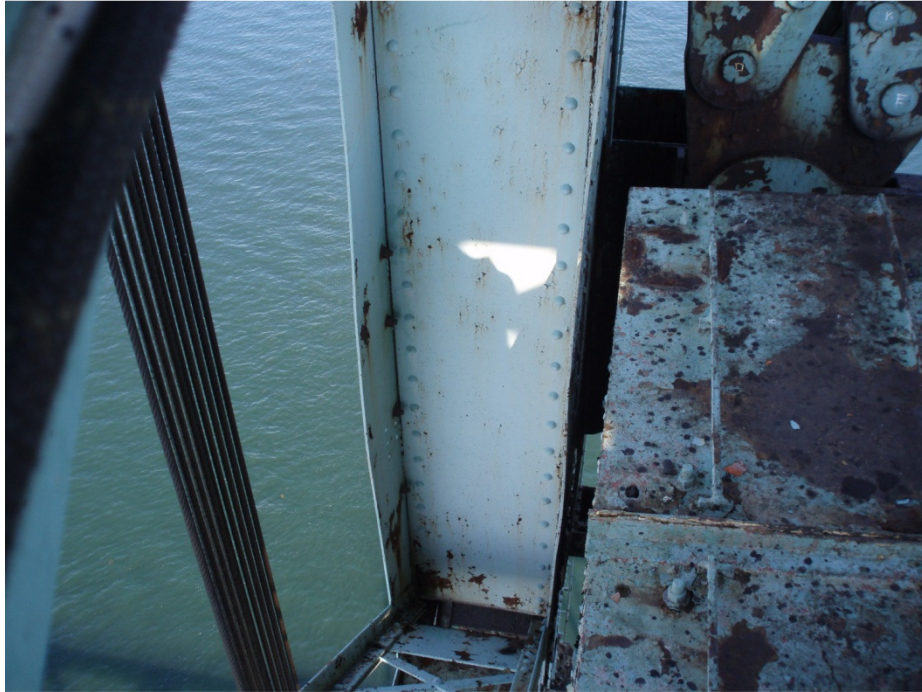
Photo 1.41: North Tower, Southeast Leg, T0-T1. Flange plates bowing.

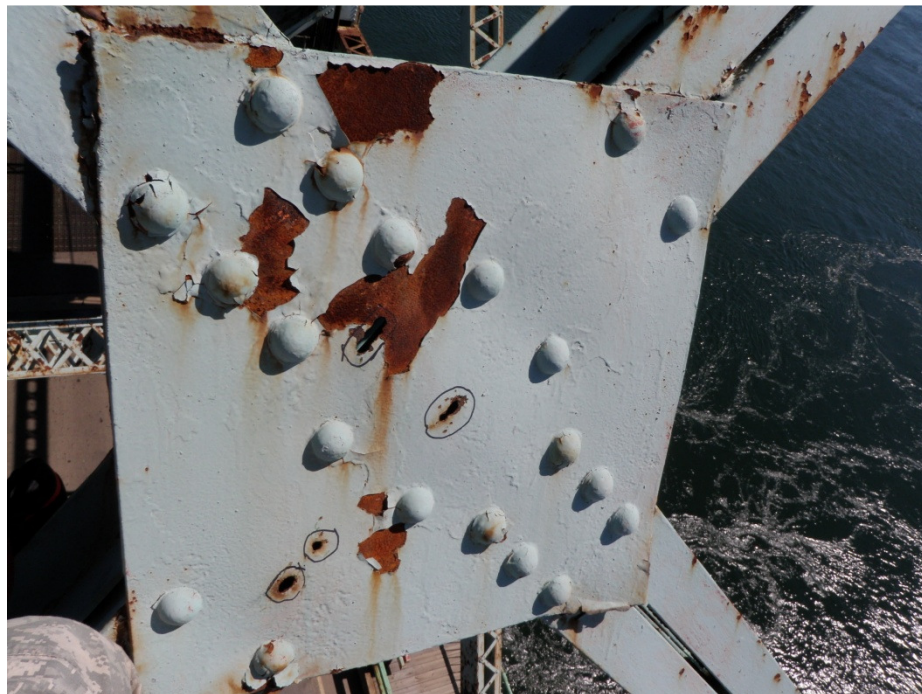
Photo 1.42: North Tower, North Face, Bracing between Panel Points T4-T5. Center Gusset has several corrosion holes.

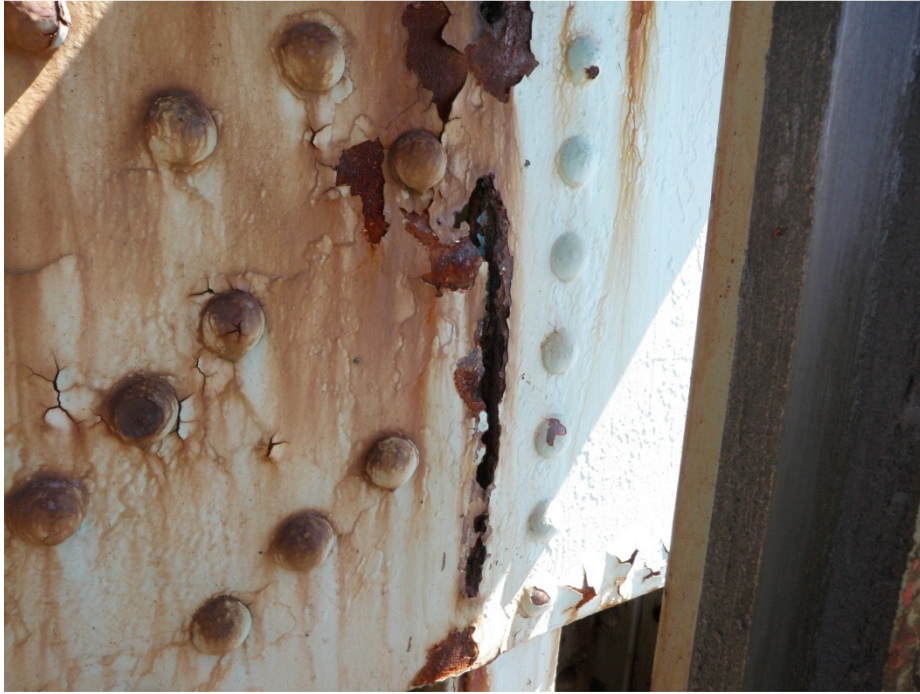
Photo 1.43: South Tower, Northeast Leg, Gusset at T3. 24" high area with 100% section loss along tower leg.

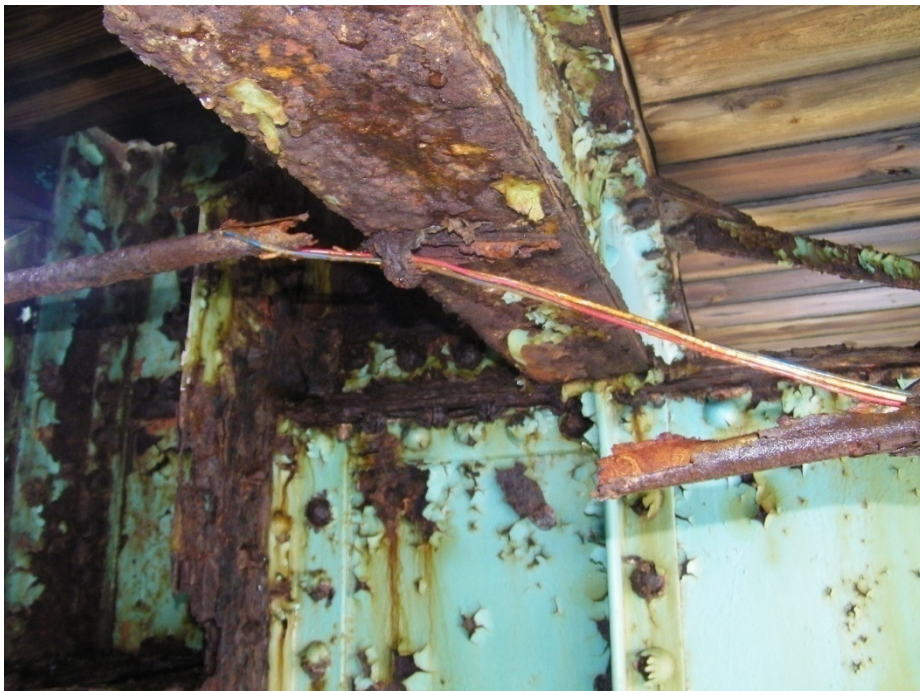
Photo 1.44: Broken utility conduit on Span 2, near East Truss Gusset L5.

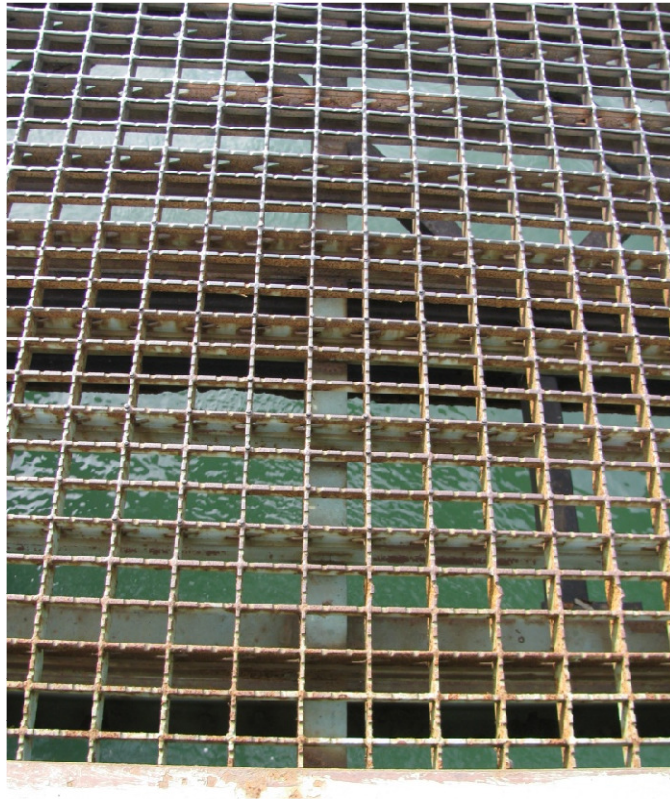
Photo 1.45: Typical condition of steel deck. Deck is rusted throughout.

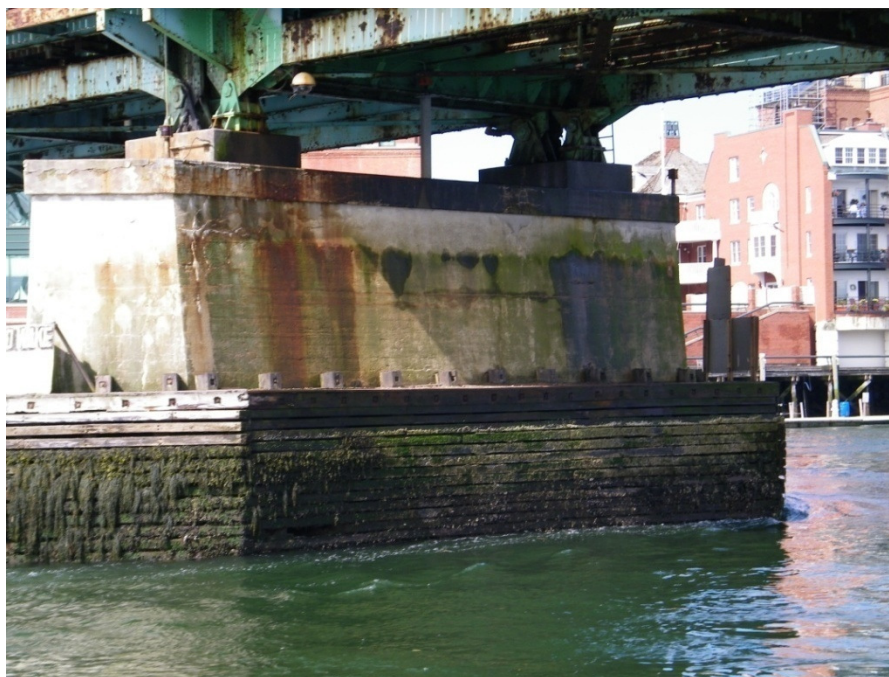
Photo 1.46: Pier 2, North face. Pier has medium to large cracks with efflorescence throughout.

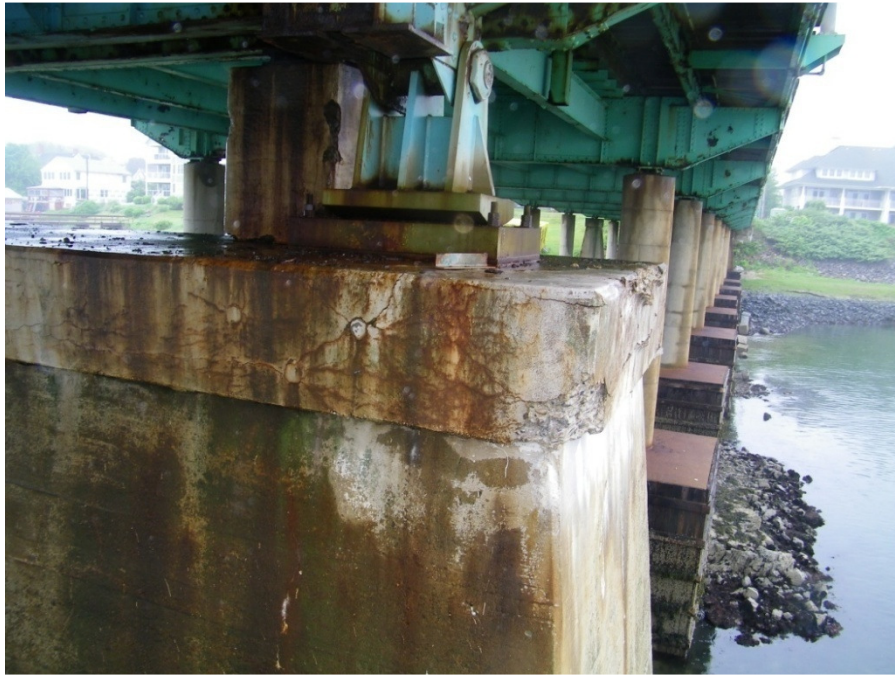
Photo 1.47: Pier 4, North face, West side. Pier cap has cracks with efflorescence, spalling and three circular patches under Kittery Approach Span 1 Southwest bearing. The three circular patches may be previous repairs for pop-outs underneath bearing.

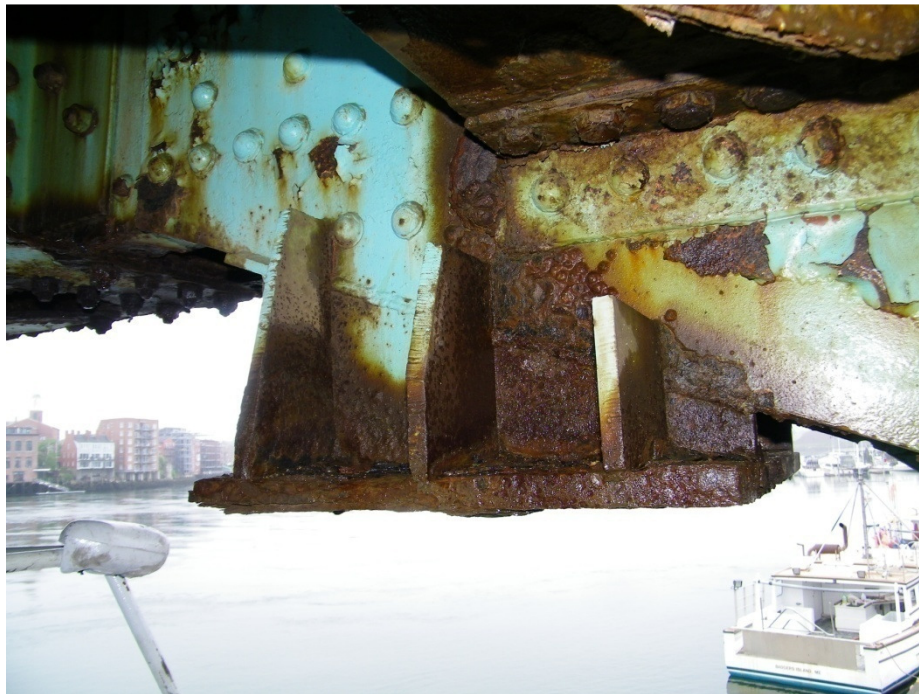
Photo 1.48: Span 1, East Truss Gusset L0. Temporary bearing welded to Gusset L0. Temporary bearings are welded to end gusset plates on Spans 1 and 3.

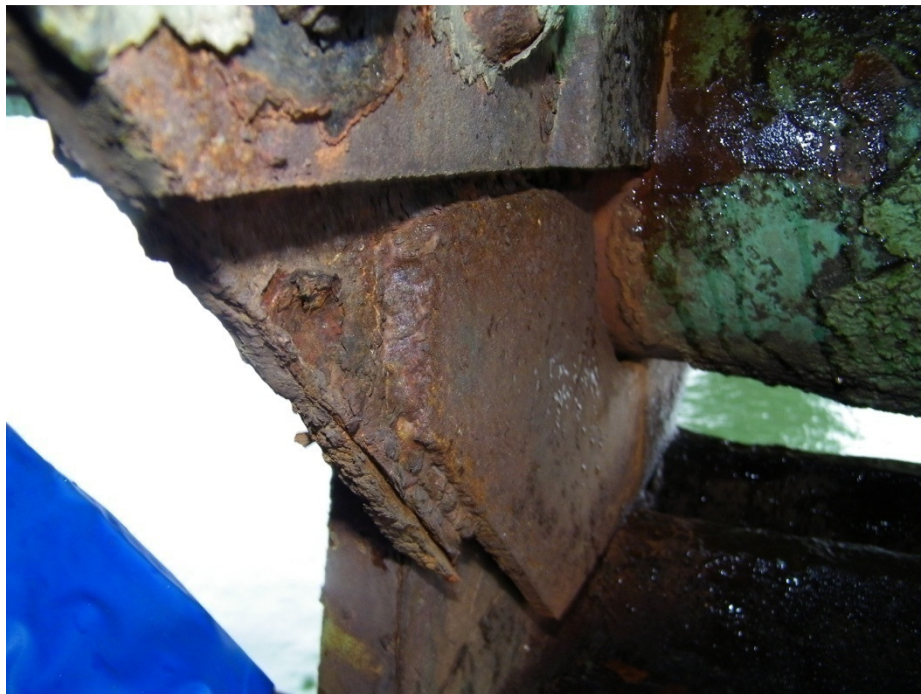
Photo 1.50: Span 2, Southwest Bearing. Truss gusset plate corroded and welded at bearing pin.

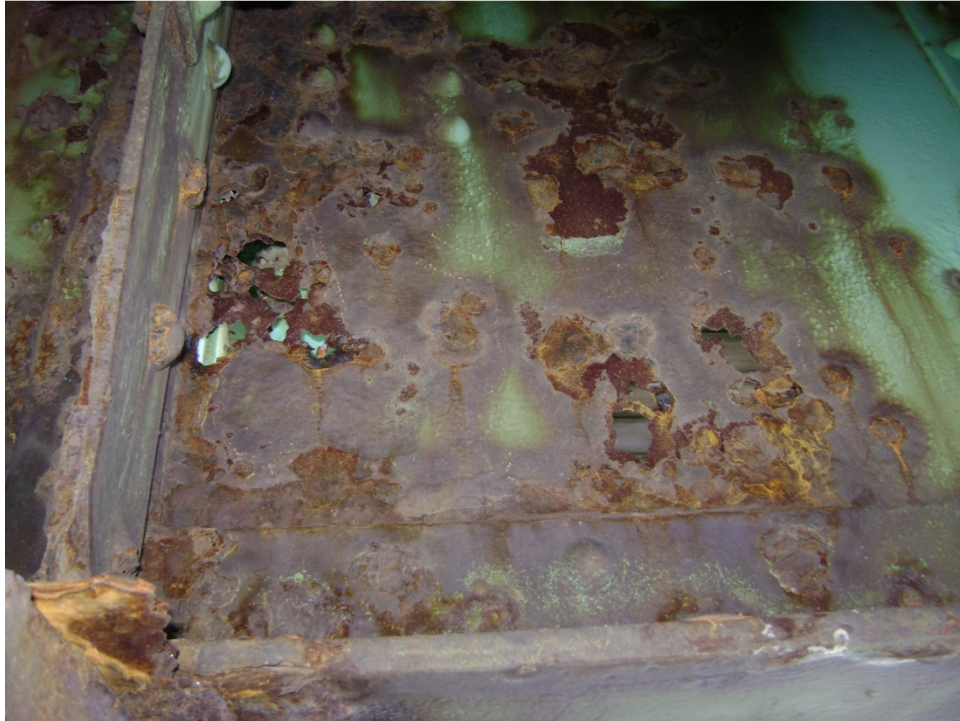
Photo 2.1: Kittery Approach, FB0, Looking South. Holes through web adjacent to East Bearing .

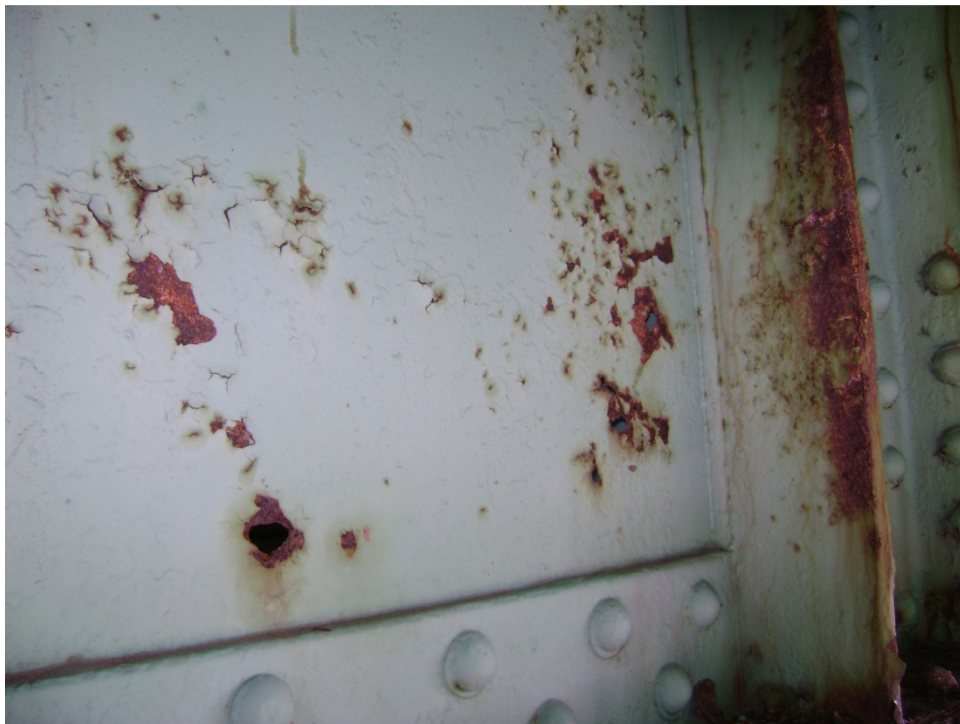
Photo 2.2: Kittery Approach, FB0, Looking South. Holes through web adjacent to West Bearing.

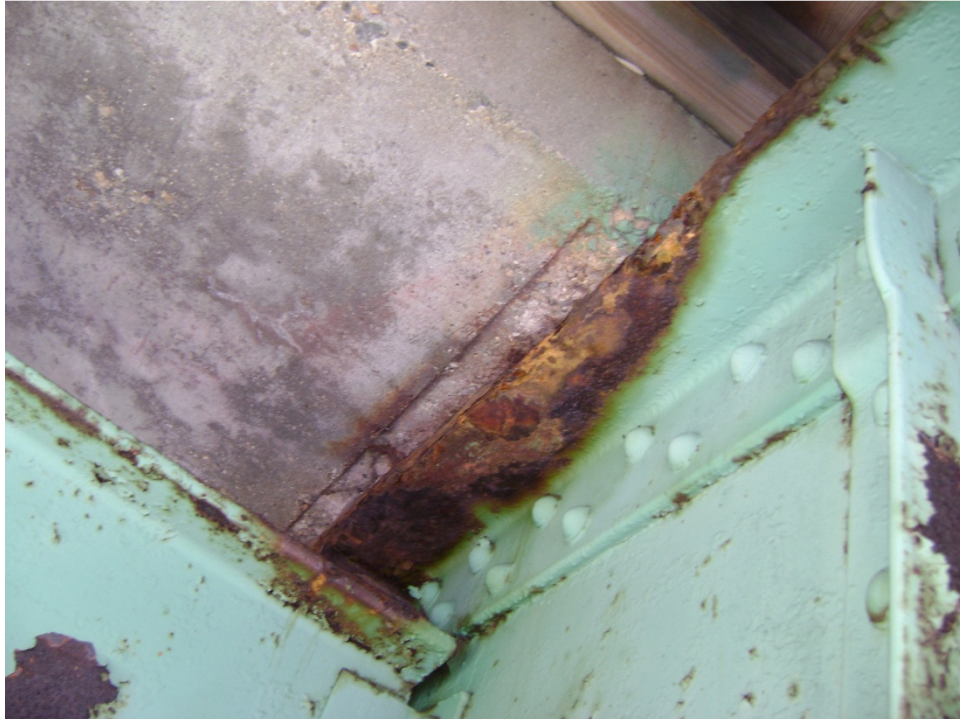
Photo 2.3: Kittery Approach, FB0. Top flange deterioration above East Bearing. Above West Bearing similar.

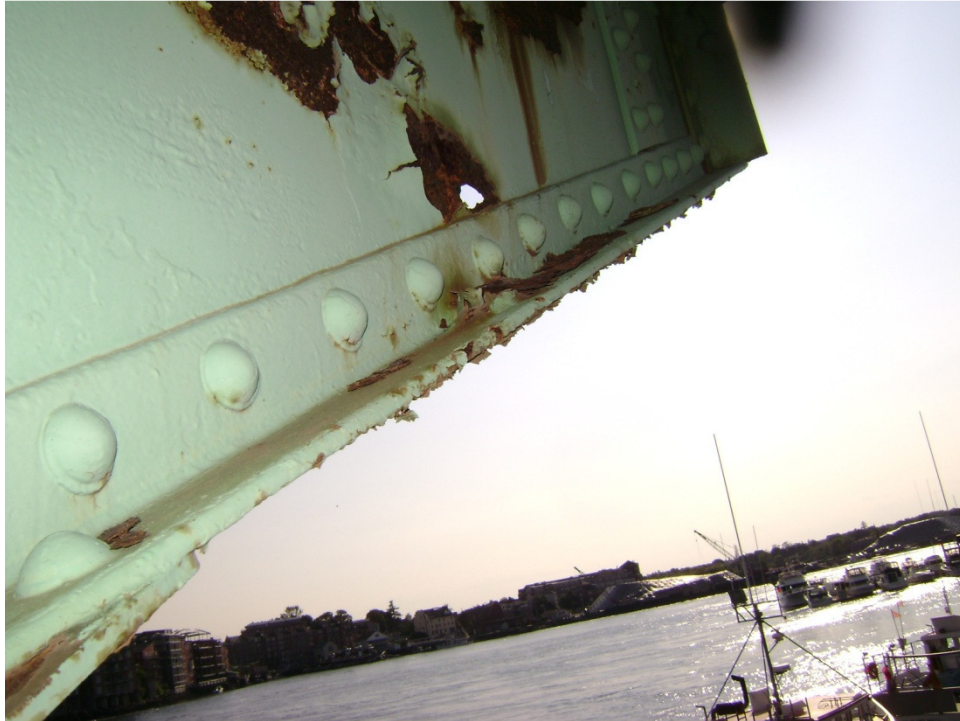
Photo 2.5: Kittery Approach, FB1. Hole through West Cantilevered Sidewalk Support web.

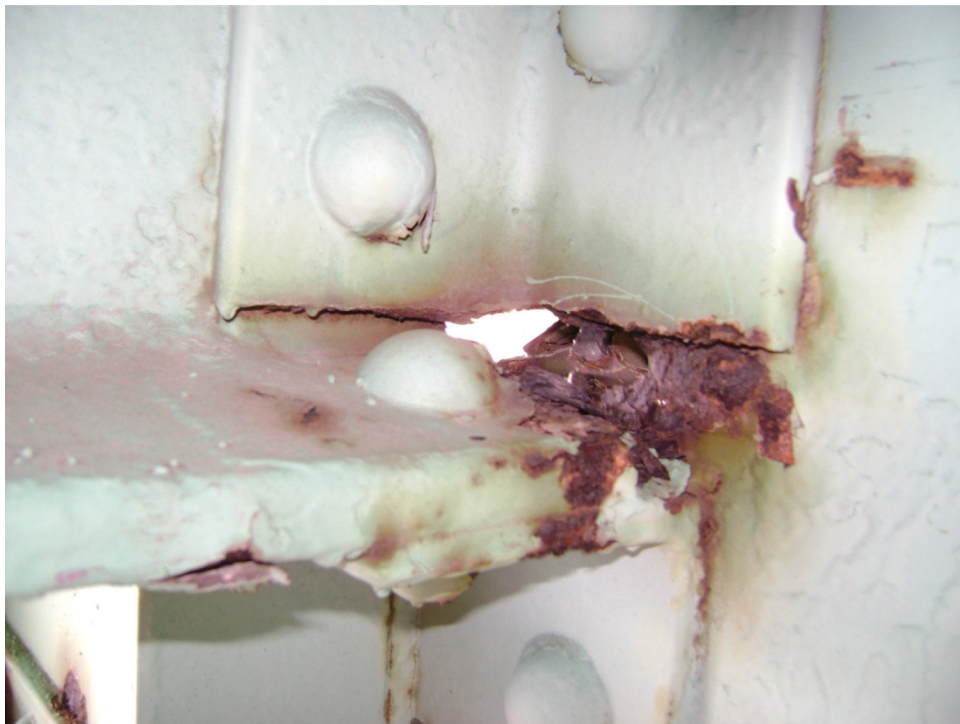
Photo 2.6: Kittery Approach, FB2. Hole through Floorbeam web below S1 connection angle.

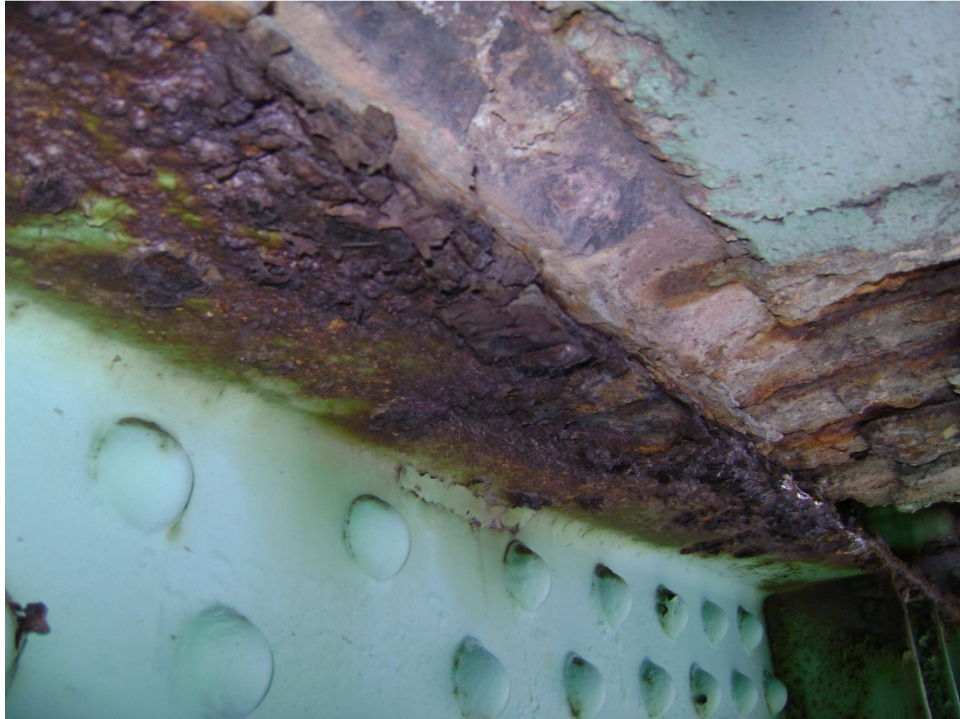
Photo 2.7: Kittery Approach, FB2. Top flange section loss above S7 and East Bearing.

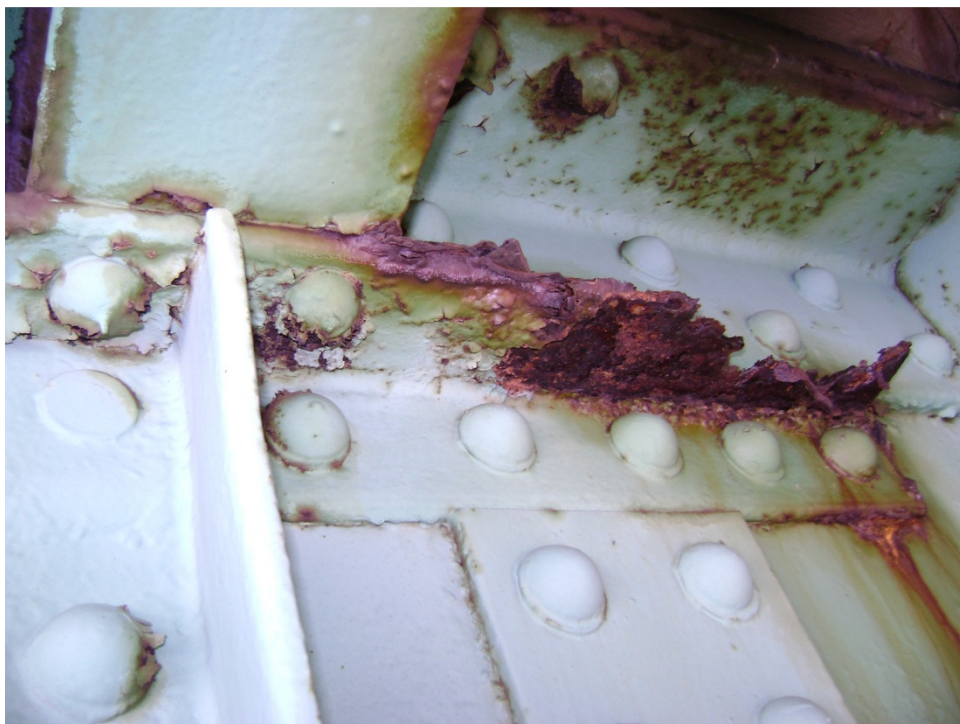
Photo 2.8: Kittery Approach, FB2. 100% section loss of top flange of Cantilever Sidewalk Support at connection to Floorbeam.

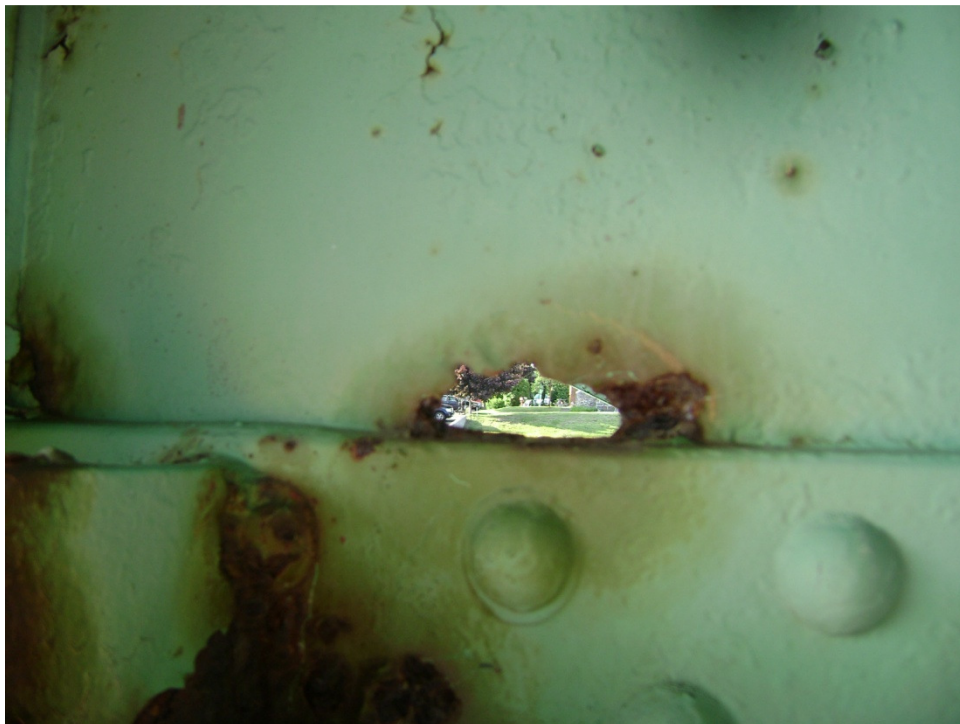
Photo 2.10: Kittery Approach, FB3. Hole through bottom of web between West Bearing and S1.

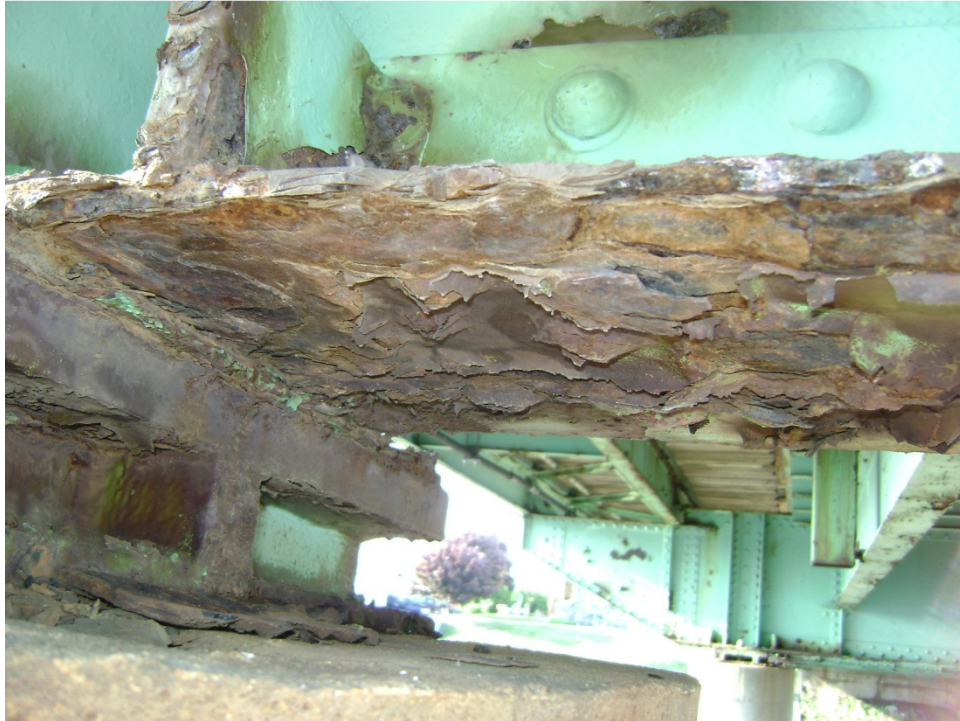
Photo 2.11: Kittery Approach, FB3. Bottom flange corrosion at West Bearing.

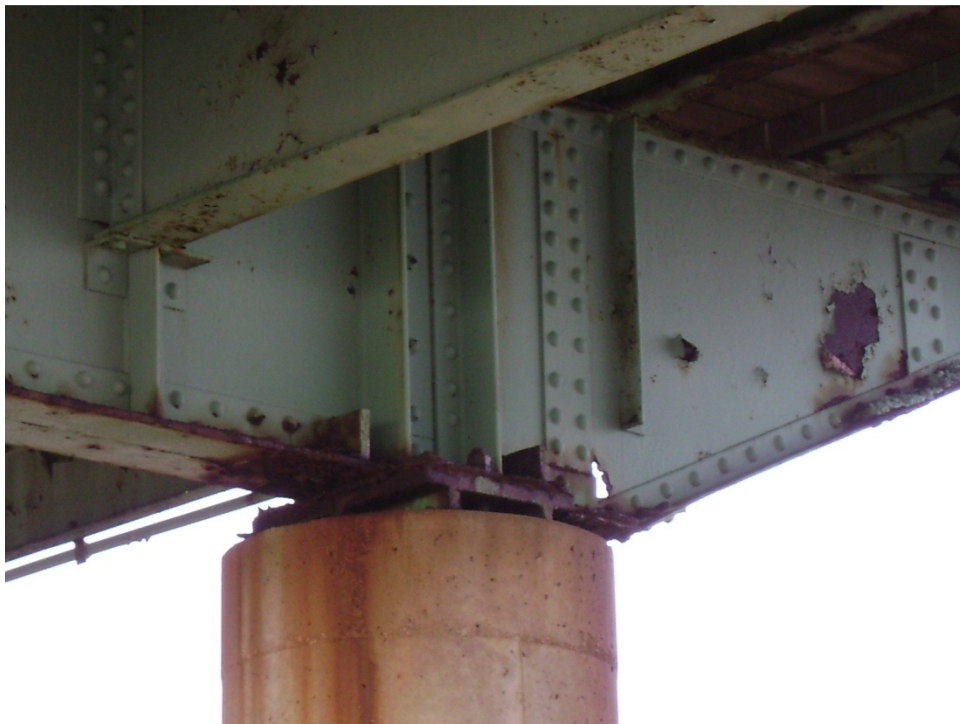
Photo 2.12: Kittery Approach, FB4. Hole through web of East Cantilevered Sidewalk Support.

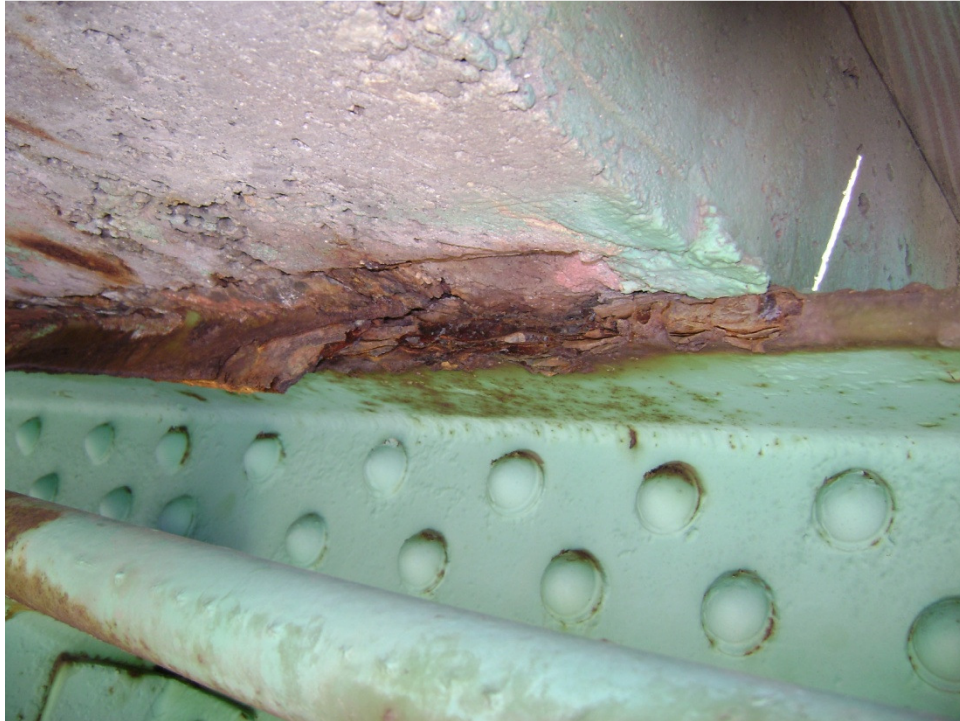
Photo 2.13: Kittery Approach, FB6. Section loss of top flange above East Bearing.

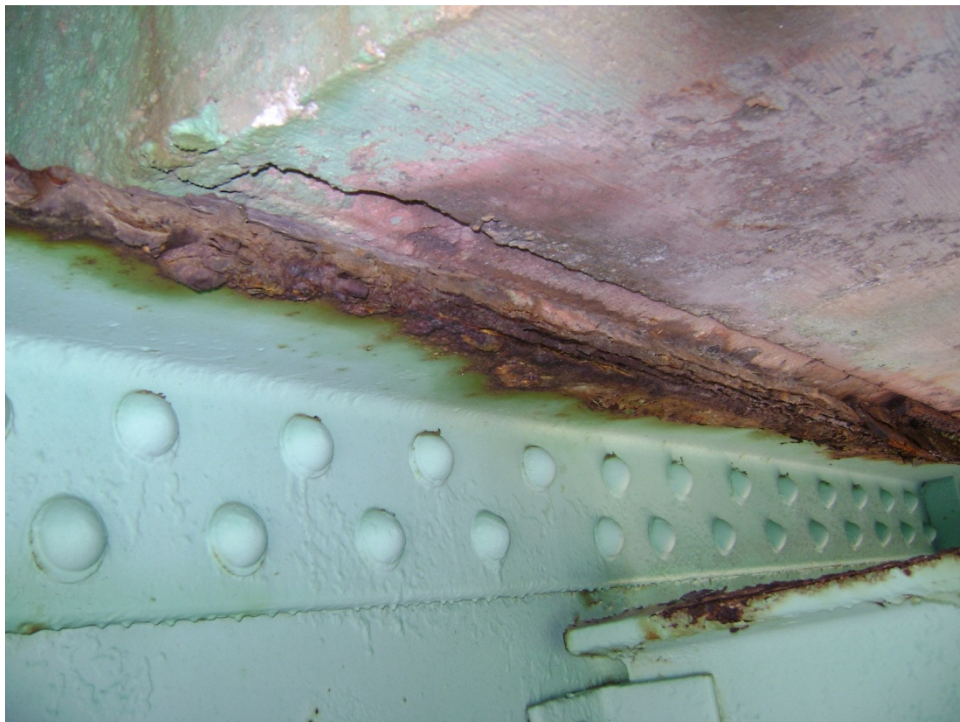
Photo 2.14: Kittery Approach, FB7. Top flange section loss above East Bearing.

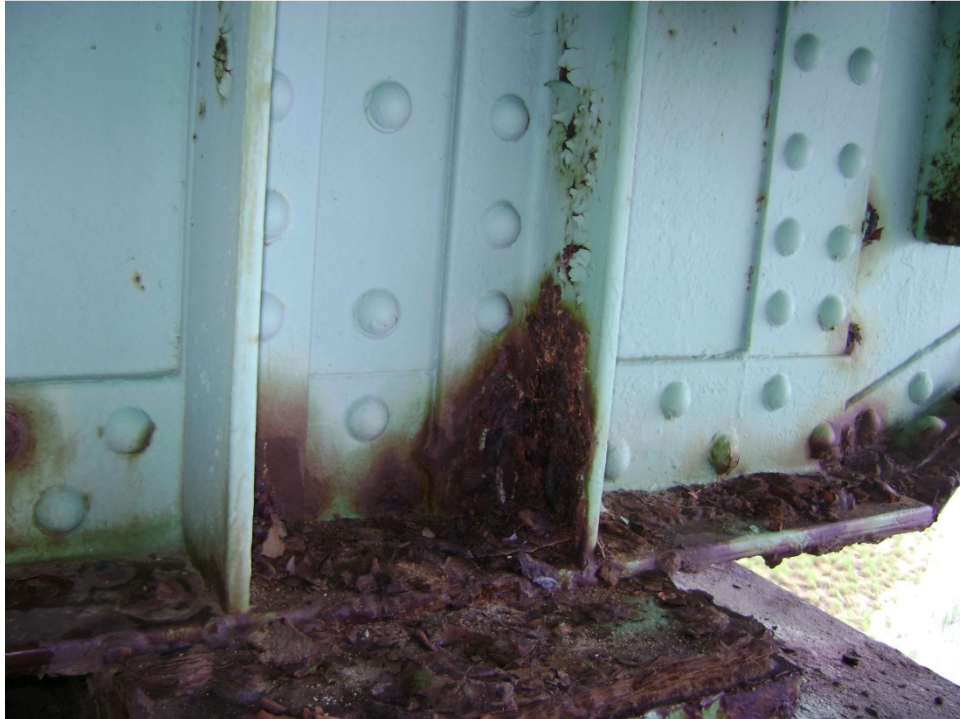
Photo 2.15: Kittery Approach, FB8. Corrosion of stiffener and bearing stiffener at East Bearing.

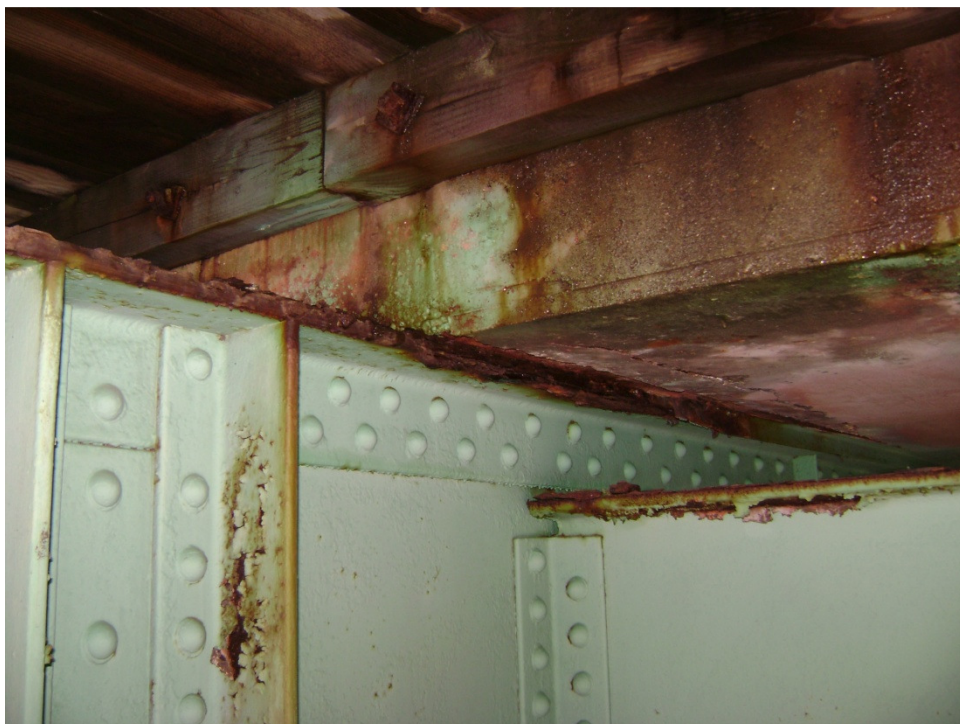
Photo 2.14: Kittery Approach, FB8. Leaking and top flange Corrosion above East Bearing.

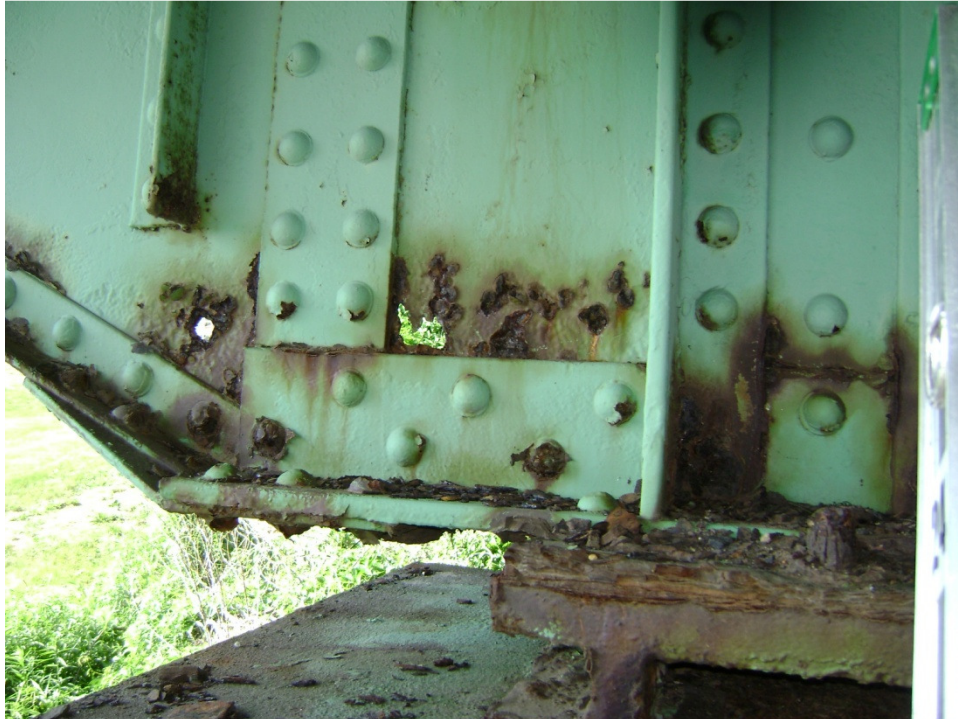
Photo 2.15: Kittery Approach, FB9. Holes through web of West Sidewalk Cantilever Support.

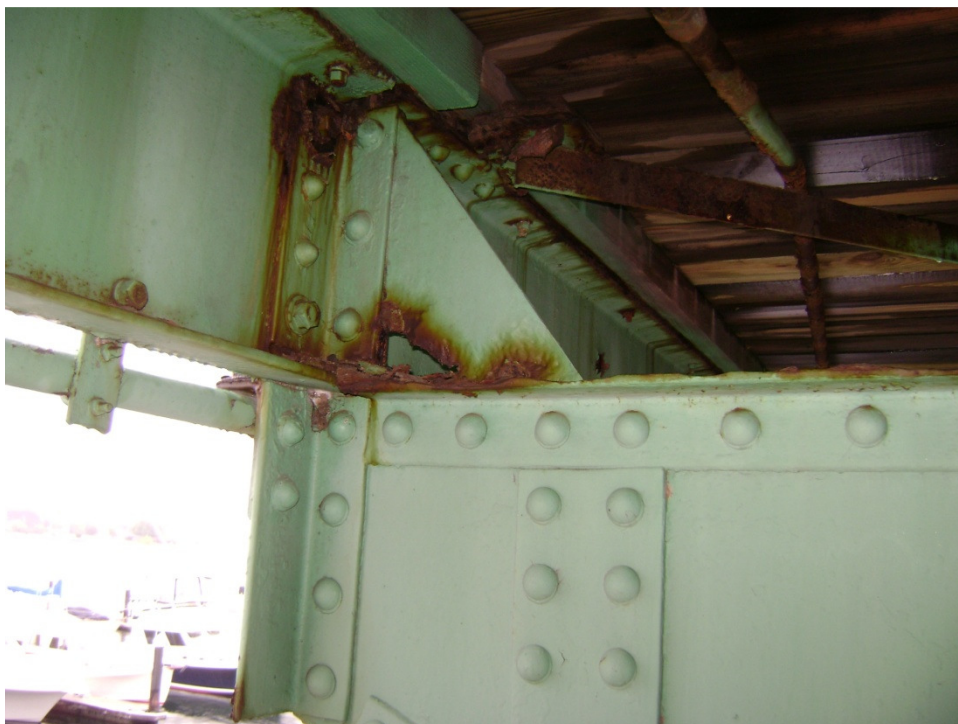
Photo 2.16: Kittery Approach, FB9. Hole through east SW4 knee brace.

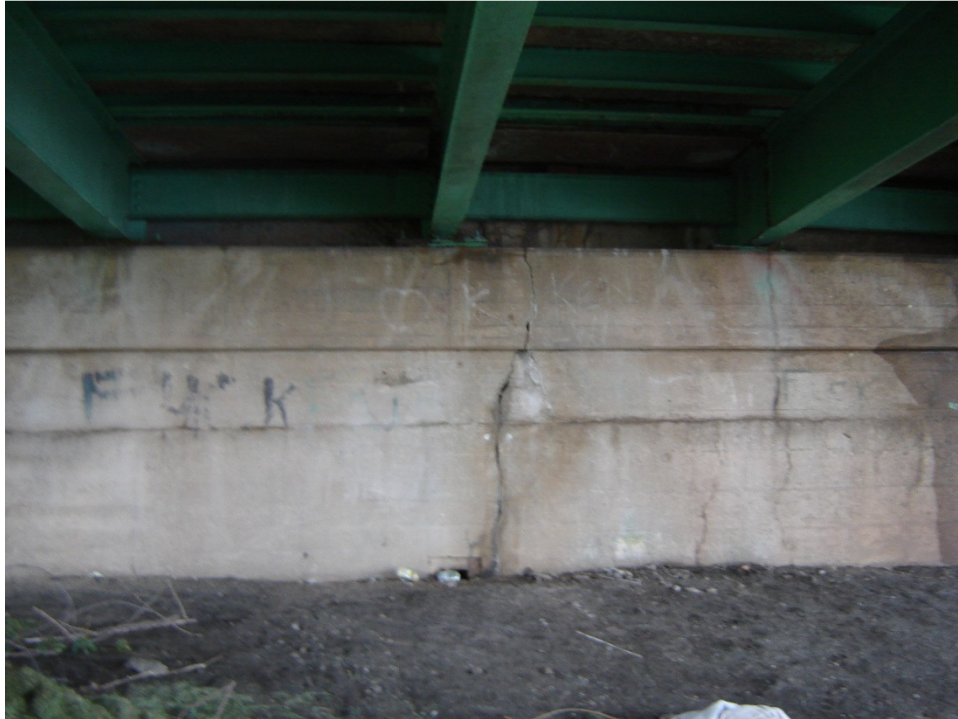
Photo 2.17: Kittery Approach Span. 3/16" crack in Maine Abutment.
